Moving from Crisis to Success

Emergency Rotational
Lining Repair Helps
Chemical Processor

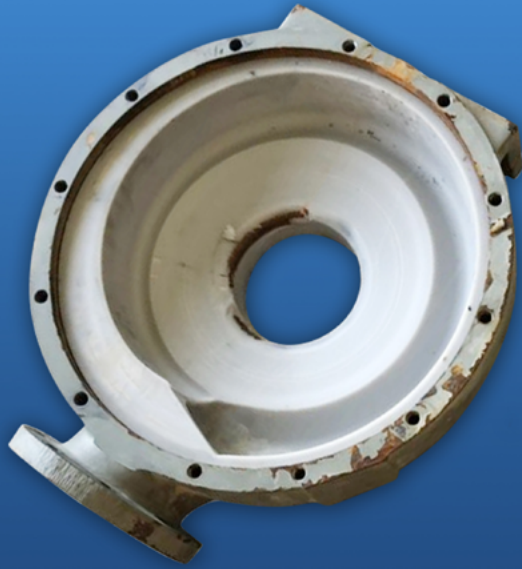
**BEFORE**

The pump was lined with perfluoroalkoxy (PFA) and intended for use in a critical processing stream. While commissioning the pump, it sustained internal damage, cutting through its PFA liner down to the metal substrate.

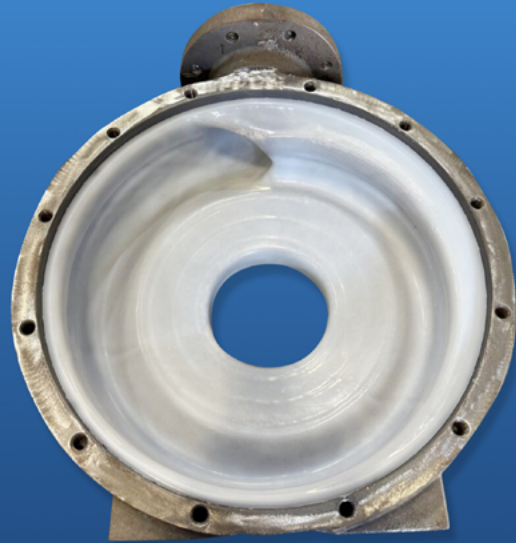
**AFTER**

RMB initiated the essential repair processes, encompassing precise machining and relining procedures, culminating in the complete restoration of the damaged pump housing. RMB accomplished this intricate repair within the same week the damaged component arrived at its repair and relining facilities.

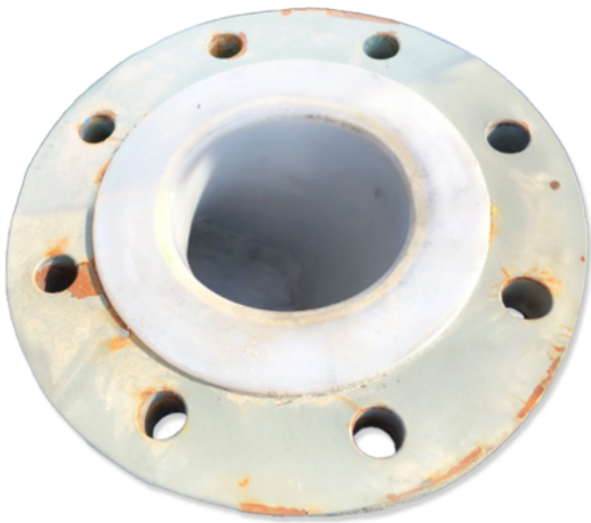
During these meetings, RMB engineers meticulously documented critical dimensions and pivotal aspects of the pump relining project. Unlike a pipe, which has a single purpose of directing fluid flow through a pipeline to a given destination, the pump housing had to contain working equipment.

RMB needed to install a new lining that would adhere to the specific dimensions of the original pump housing and lining supplied by the OEM. Only the exact dimensions could facilitate the smooth operation of the equipment inside the pump housing, such as free movement for the impeller.

Because the team had no access to the OEM drawings, RMB engineers had to reverse-engineer the pump housing. A series of meetings helped coordinate accurate measurements with the processor's engineering team.

Finally, RMB also had to account for grooves in the casing and supply a cap for the end flange. This would ensure an even and binding layer of PFA that would supply the necessary performance and lifespan required by this project.

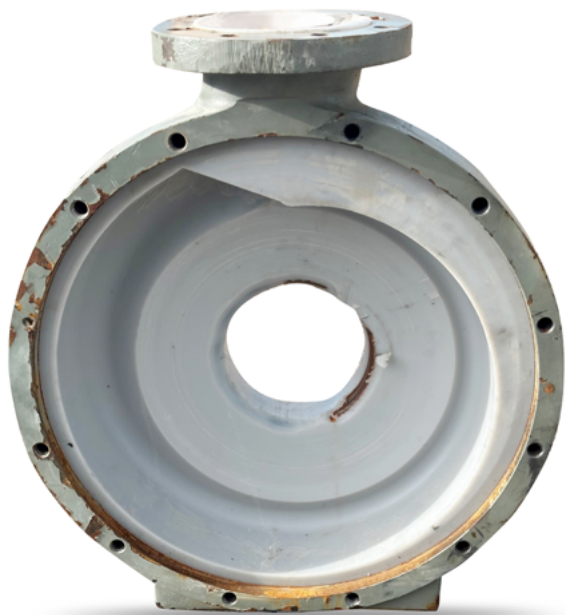
Pumps with an end flange require specialized tools to seal these components and prevent resin leakage. Armed with an array of specialized tools and a fully equipped machine shop, RMB can

provide end closures and address the unique challenges of rotolining unconventional surfaces. RMB has the requisite rings and tools to effectively seal end flanges and extend the raised bed dimension as needed. This enables the team to swiftly adapt to unique end configurations, seamlessly incorporating special closure plates when necessary.

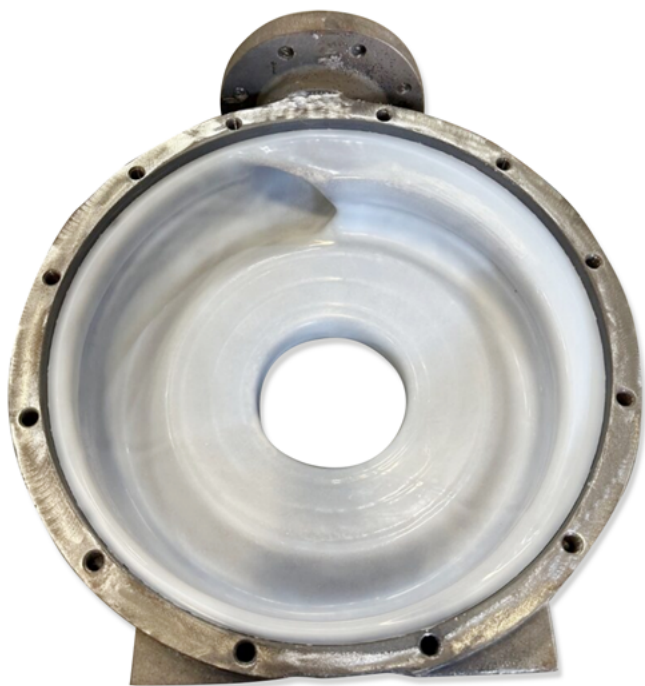
In summary, RMB successfully replaced the PFA lining to help the specialty chemical processor commission and start its new processing line. Frequent communication and meticulous planning helped RMB successfully reverse-engineer the project to achieve a lining that exactly fit the measurement of the pump supplied by the OEM, ensuring the smooth operation of critical equipment.
