RMB BIO-ARMOR™
BIOFOULING PREVENTION

RMB BIO-ARMOR™
Lining System Provides
Rapid, Durable Solution
for Aging Infrastructure

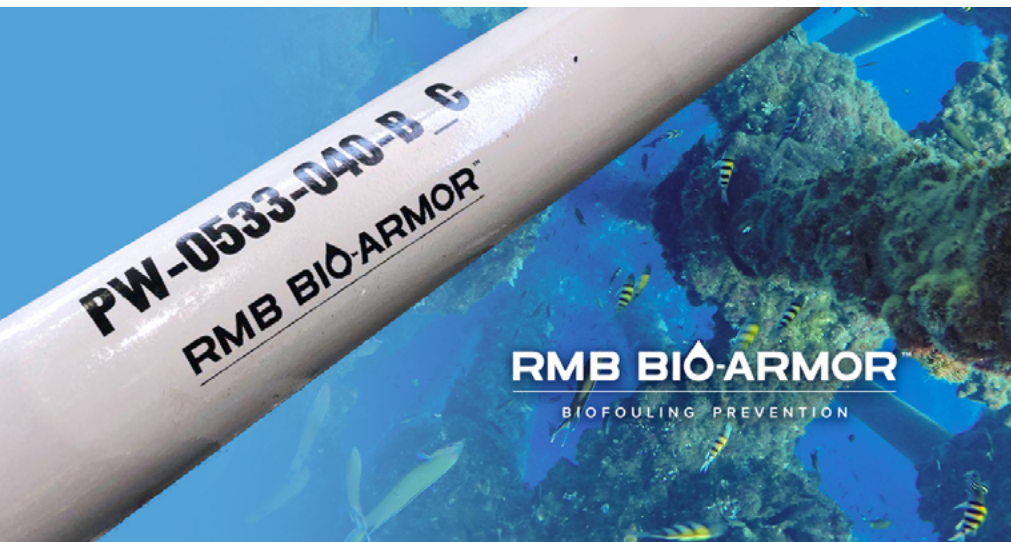
The BIO-ARMOR lining system was selected for its superior corrosion resistance and durability in marine environments. The rotational molding process creates a seamless, impermeable barrier that protects the carbon steel caisson structure from degradation. Compared to FRP composite construction, the steel structure of the caisson provides superior strength. RMB expedited the application process and allowed for completion within the tight timeframe, minimizing downtime for the oil company's operations.

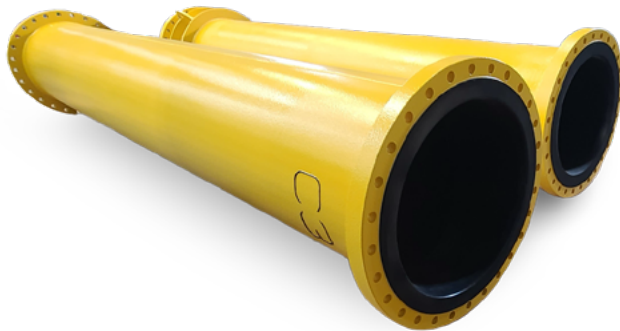
RMB provided a 100% corrosion protection system, including an HDPE liner, exterior topcoat, and polysulfide sealant to address vulnerabilities at material interfaces. The polysulfide sealant, a technology transfer from RMB's aerospace division, was particularly crucial in sealing the small gap between the liner and the exterior coating, preventing corrosion in this vulnerable area that will be exposed to the corrosive seawater.
